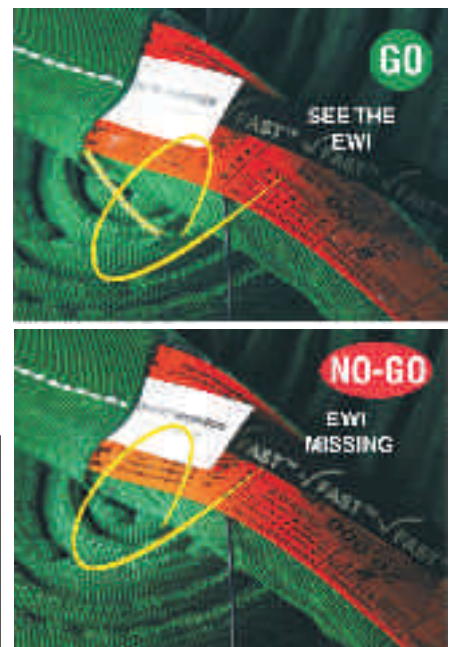
Fast® Inspection System, US Patent #7,661,737. Foreign Patents Pending

The next question is this: Is there a mechanical way to determine “hidden” UV damage in a roundsling? The answer is yes! On February 16, 2010 the United States issued a patent to Slingmax® Rigging Solutions (US #7,661,737) for a pre-failure warning indication system for all roundslings.
